Embankment failures related with bedrock slide in the Shimanto Belt, south Kyushu, Japan

Landslides Vol.39 No.4 Separately Printed.

Key words : bedrock slide, Shimanto belt, subduction, accretionary complex, turbidite, olistholiths

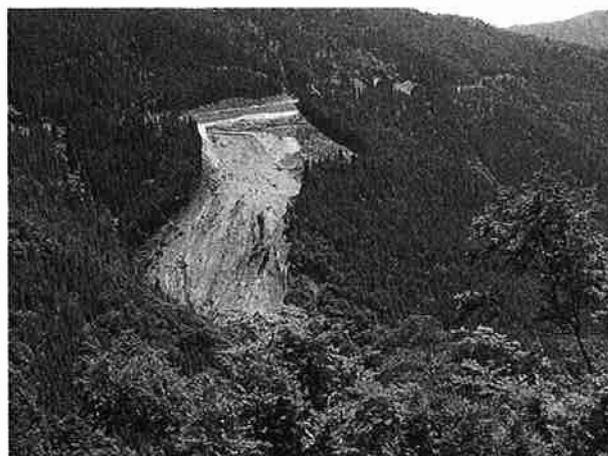
Photo 1 Side view of landslide area. Looking to NE direction

Width of Landslide Zone = 70m, Length of Landslide Zone = 150m
Middle part of hill slope indicating delineation of gullies by debris flows.

The study area is located at the Umenoki-Tsuru forest road, northern part of Mizukami Village, Kuma region, SE Kumamoto Prefecture, and situated at the down slope side of roadway embankment (Fig. 2 and Photo 1). The slopes are generally high and steep (950-1000m), and the rocks of the region are highly fractured. Massive to bedded sandstone bodies are exposed on the middle part of slide area (Block-B), and underlying slaty shale units are occurred at the toe of

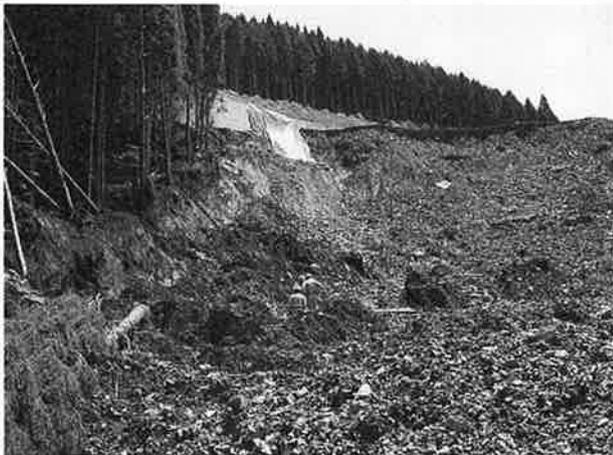
At the head of the landslide zone (Block-C), slip surface developed on the clayey soil layers and the thick embankment fill was collapsed to down-slope of the hillside (Photo 2). The main scarp, about 5m-10m high, was clearly formed at the top of the slope and many seepage zones are occurred on the slip surface. This slip surface is thought to be the boundary of collapsing embankment fills and underlying clayey soil materials. Shear cracks are also found on the slip surface and western part of slide-wall (Photo 2).

Photo 2 Head scarp exposing black and reddish brown clayey soil layers showing failure plane with striations. Note, debris from the embankment slides consisted of fragmented sandstone and clayey soil. The soil cover was less than 1m thick and the sliding exposed the underlying bedrock

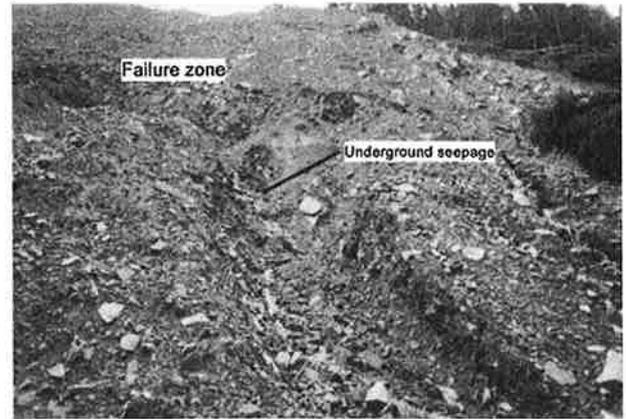
Photo 7 Gully erosion starting from the boundary between Sandstone unit (upper) and slaty shale unit (lower). Underground springs and slope failures occurred at the lower part of Landslide area (Block-A)

quick condition were found in the area of the slip surface between the Block-B and Block-A (Photos 7 and 8).

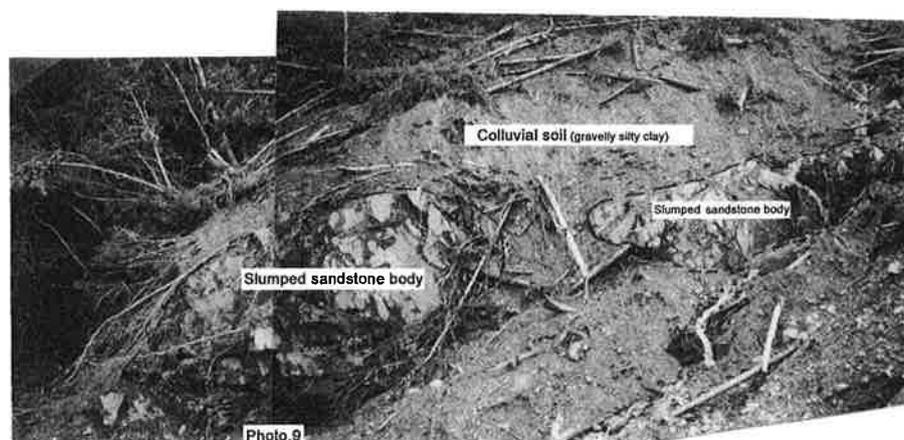
Photo 10 Large sandstone bodies with underlying slaty shale layers drifting along the erosional gully at the western side of landslide area
