Ecology and Geomorphology of Stream: A Study of Buyo Creek near Okshitpin Village Tract, Padaung, Bago Division

Mya Thaug¹, Nay Win Oo², Aung Kyaw³, Associates⁴

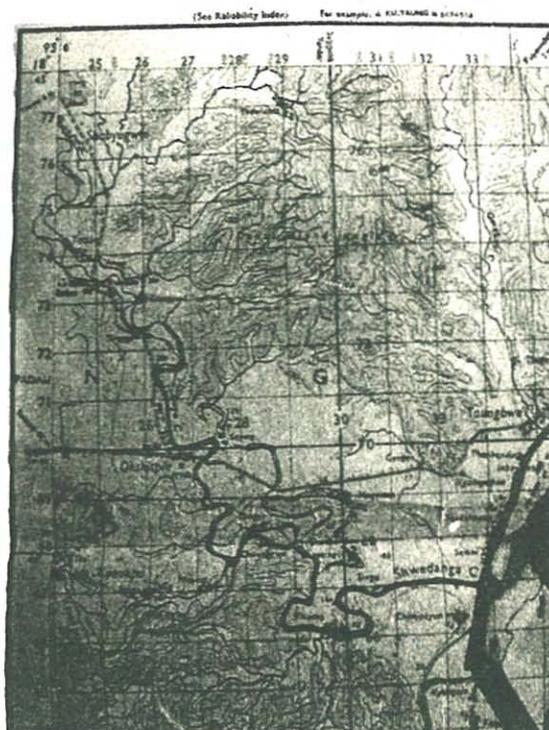
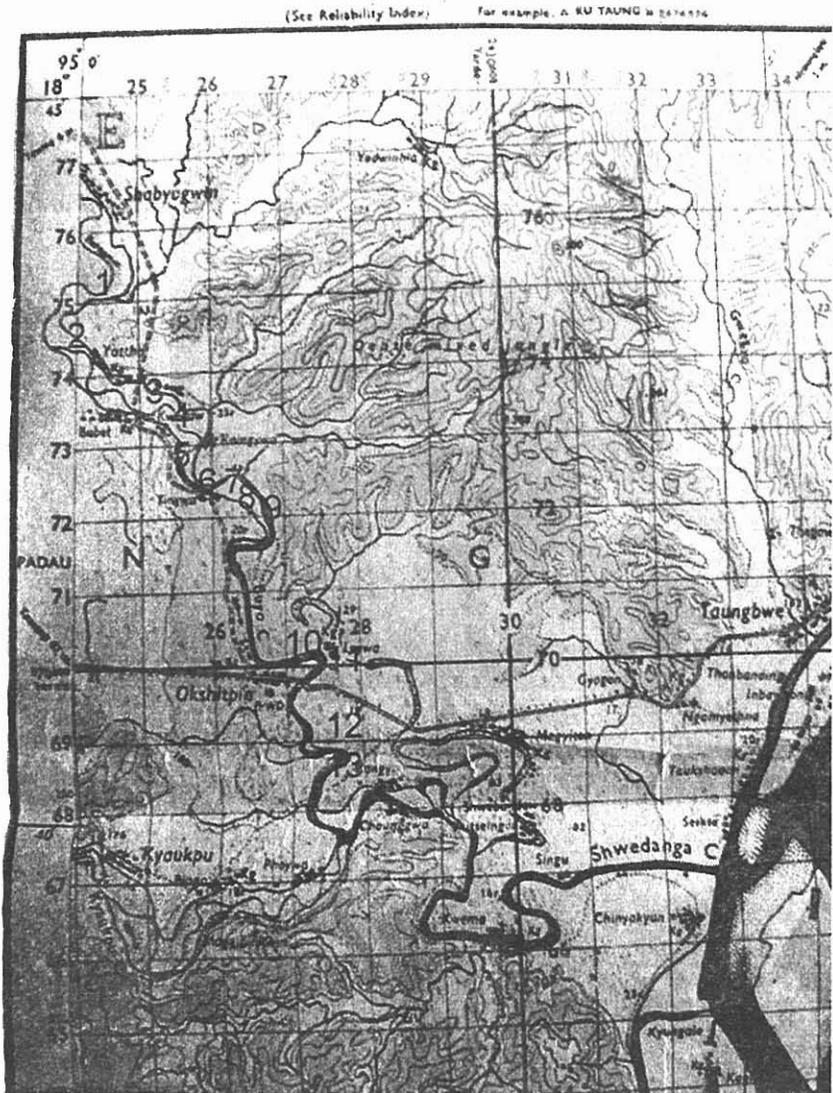
Fig. 1. Location of sample reaches along the Buyo Creek.

Buyo creek drains the eastern slopes of the Western Mountains Range Area (Fig. 1). Buyo Creek flows from north-west to south-east along which many villages are situated such as Tatha, Bubet, Kwedaw, Kaingywa, Yinywa, Leywa, Okshitpin and Kongyi, etc. All these villages are included in Padaung Township, Bago Division. The creek flows through the Okshitpin Village and join Shwedanga Creek before draining into the Ayeyarwady River. These creeks differ from one another in that they are very dynamic in response to geology, and anthropomorphic conditions. During the rainy season the whole channel is filled with water and the water level reached to about 20 feet above the floodplain. But in summer, the water is only along the narrow active channel.

Thirteen sample reaches were chosen and surveyed along Buyo Creeks. These reaches were chosen based on the diversity of channel morphology during stream reconnaissance. A layout of these reaches can be seen in Figure 1. Reach surveys included an assessment of general habitat condition, stream geomorphology, water quality, discharge, substrate condition, and relative fish abundance.
