## Water Quality Assessment of Ground Water in Public Two Dug Wells Beside Shwe-Ta Chaung Canal

### Abstract

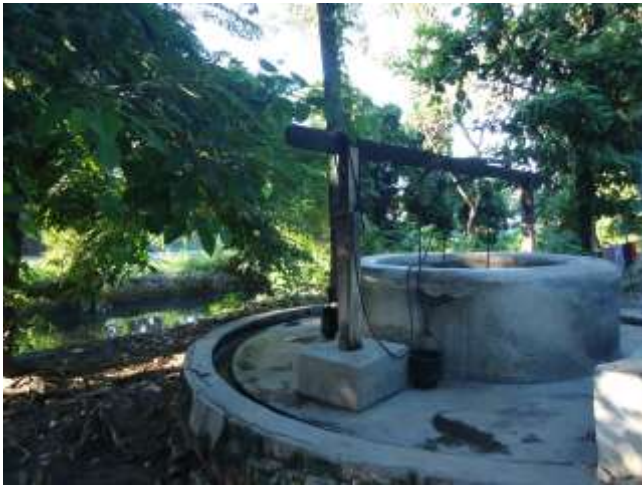
Yarma Dug Well lies at approximately 21° 55' 45" north latitude and 96 ° 4' 4" east longitudes. The well was constructed over 100 years ago. Typically, the well-base is about 30 feet away from Shwe-Ta-Chaung canal. A garbage area is about 75 feet away from the well-base. The diameter of the well is 6.5 feet and the thickness of the well is 1 foot, which is constructed with a brick lining. The height of the well base is 1.5 feet above the ground. The depth to water from the top of the well casing is 15.35 feet on 12<sup>th</sup> October 2017. The depth to water from the top of the well casing is 20.5 feet on 5<sup>th</sup> March 2018. The photograph of Yarma Dug Well beside the Shwe-Ta-Chaung canal is shown in Figure (1). The width of Shwe-Ta-Chaung canal near Yarma Dug Well is about 25 feet and it lies approximately at 21° 55' 46" north latitude and 96° 4' 3" east longitude. Raw sewage from downtown Mandalay flows into the canal. In this area, the canal is not lined by concrete. Waste water is in direct contact with the ground in the canal. Yarma Dug Well region is located adjacent to the rubbish filter site along Shwe-Ta-Chaung canal. The photograph of trash located near the Yarma Dug Well in the bank of the Shwe-Ta-Chaung canal is also shown in Figure (2).

Figure (1) Yarma Dug Well beside the Shwe-Ta-Chaung canal

The sewage canal should be reconstructed with appropriate protection. The canal should be constructed with concrete. The canal is too shallow so that it is flooded during the rainy season and the sewage reached to the base of the well. So the garbage should not be dumped near the well base. It is indicated that the water supply wells are impacted by contamination associated with waste water. Humans and animals should not use the wells located near the waste water canal for any purpose.

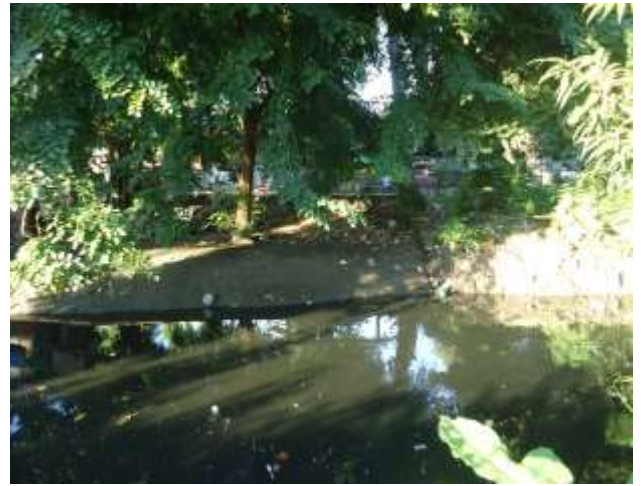
Figure (2) Trash located near the Yarma Dug Well on the bank of the Shwe-Ta-Chaung canal

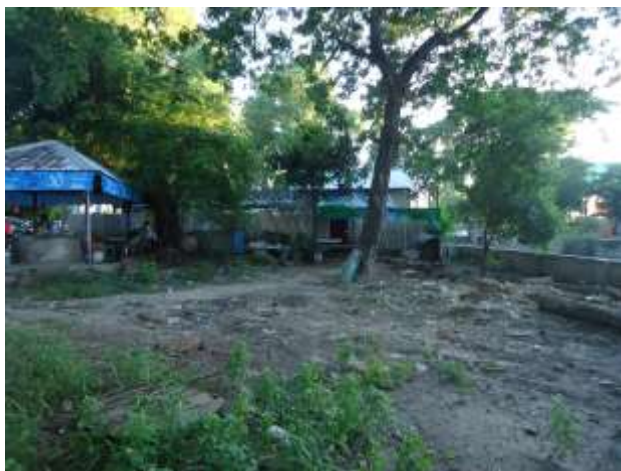
Cow Lake Dug Well lies at approximately 21° 56' 19" north latitude and 96 ° 4' 21" east longitudes. The well was constructed over 100 years ago. Typically, the well-base is about 45 feet away from Shwe-Ta-Chaung canal. A garbage area is about 95 feet away from the well-base. The diameter of the well is 4 feet and the thickness of the well is 11 inches, which is constructed with a brick lining. The height of the well base is 9 inches above the ground. The depth to water from the top of the well casing is 21 feet on 12<sup>th</sup> October 2017. The depth to water from the top of the well casing is 14 feet on 5<sup>th</sup> March 2018. The photograph of Cow Lake Dug Well beside the Shwe-Ta-Chaung canal is shown in Figure (3). The width of Shwe-Ta-Chaung canal near Cow Lake Dug Well is about 20 feet and it lies approximately at 21° 56'18" north latitude and 96° 4' 21" east longitude. Raw sewage from downtown Mandalay flows into the canal. In this area, the canal is lined by concrete. Waste water is not in direct contact with the ground in the canal. The photograph of trash located near Cow Lake Dug Well in the bank of the Shwe-Ta-Chaung canal is also shown in Figure (4). The photograph of location map of two research sites in Tanpawaddi is represented in Figure (5).

Figure (3) Cow Lake Dug Well beside the Shwe-Ta-Chaung canal

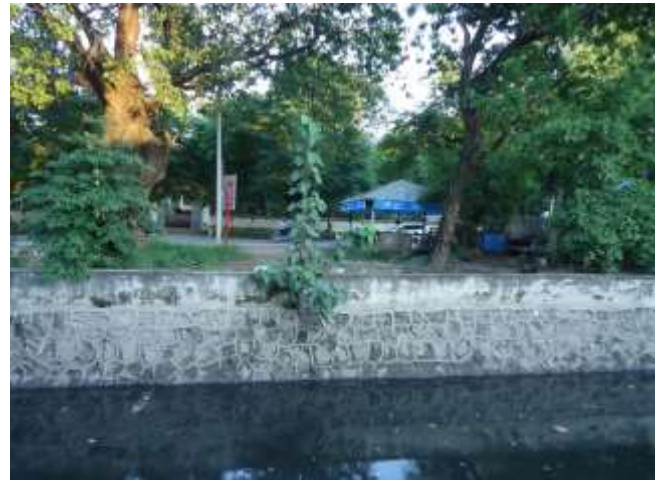
Figure (4) Trash located near Cow Lake Dug Well on the bank of Shwe-Ta-Chaung canal
